**BLACKWOOD LAKE.**

**(NJ 00800).**

Delaware River Basin, South Branch Timber Creek,  
Camden County, New Jersey.

**PHASE 1 INSPECTION REPORT.**

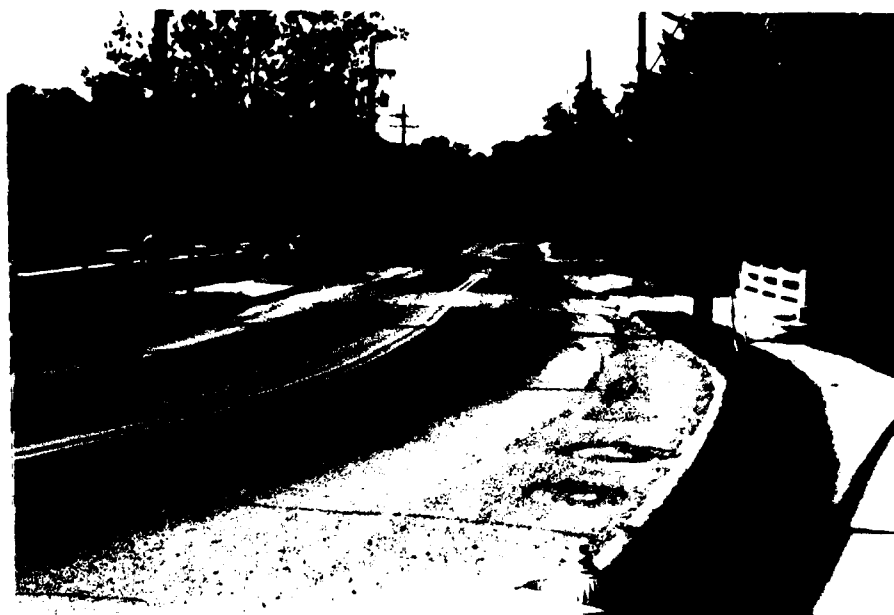
View of Dam Crest
